IAC-17.B4.3.3

ANALYSIS OF THE COMMUNICATION ANOMALY DURING E-ST@R-2 MISSION OPERATIONS

S. Corpino <sup>a\*</sup>, F. Stesina <sup>a</sup>

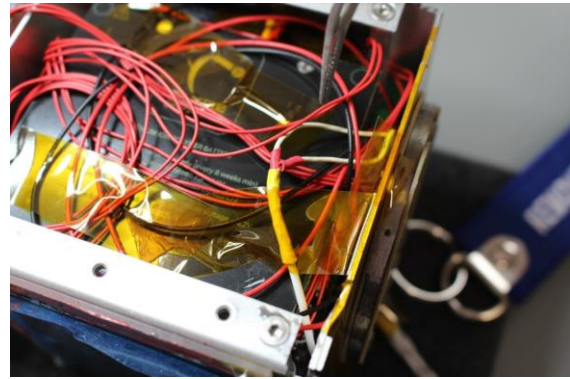
2. Incomplete radiation pattern can be caused by a faulty connection during the integration phase: a wrong connection between the coaxial cable and the two antenna pieces. Photos taken during integration (Fig. 6) show that two twisted cables are used to lengthen the connection in order to ease the integration. As these cables are not coaxial, this configuration does not behave as a transmission line, instead these cables cause a significant loss and, as consequence, the antenna has not a main lobe but several side lobes, that fall down power and reduce gain and beamwidth.

Fig. 6: Details of the antenna connection

A faulty connection between the coaxial cable and the two antenna pieces generates high line losses. Two twisted cables are used to lengthen the connection in order to ease the integration. As these cables are not coaxial, this configuration does not behave as a transmission line instead these cables cause a significant loss and, as consequence, antenna has not a main lobe but several side lobes, that fall down power and reduce gain and beamwidth.

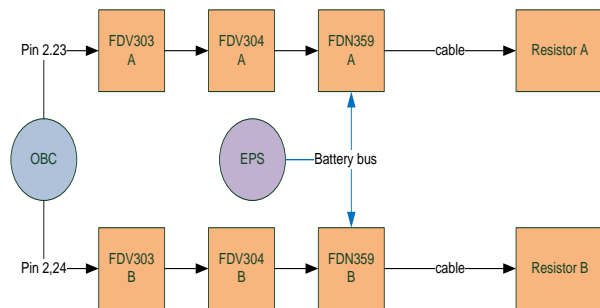
A second cause of incomplete antenna pattern and/or reduced antenna gain is a failure on the antenna opening circuit lines that prevents the antenna deployment. The antenna opening circuit (Fig. 7) presents a redundancy by design: two independent circuits (based on two cascades of three MOSFET) contribute to cut the fishing wire. This redundancy allocates a low probability of failure occurrence because it would mean that both lines failed either during the launch or in the first 30 minutes of the mission.

Fig. 7: antenna opening circuit block scheme
